Corrosion Coupons May Not Be Useful for Predicting Data Center Equipment Failure Rates

Indoor Air 2011 Presentation

June 9, 2011– Indoor Air, Austin Tx

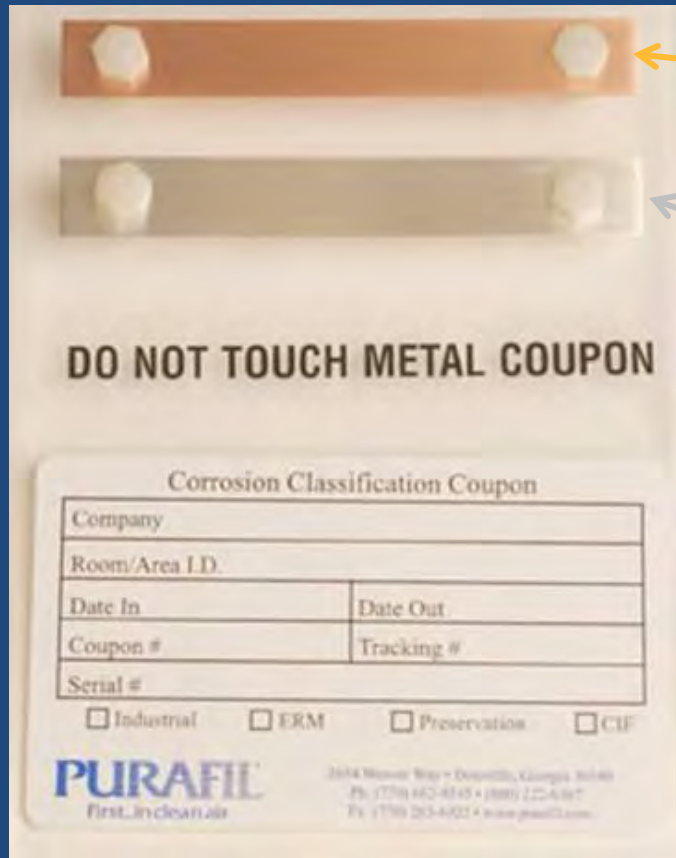
before exposure

Reactivity Monitoring Corrosion Classification Coupon (most common air corrosivity measurement method)

copper strip

silver strip

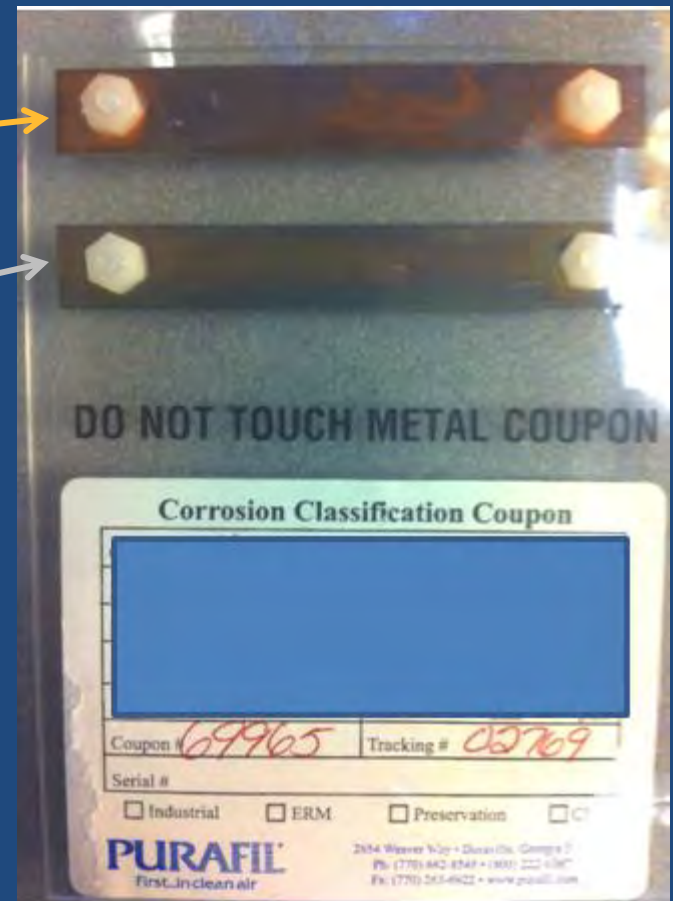
after exposure

exposed for 30 or 60 days typical

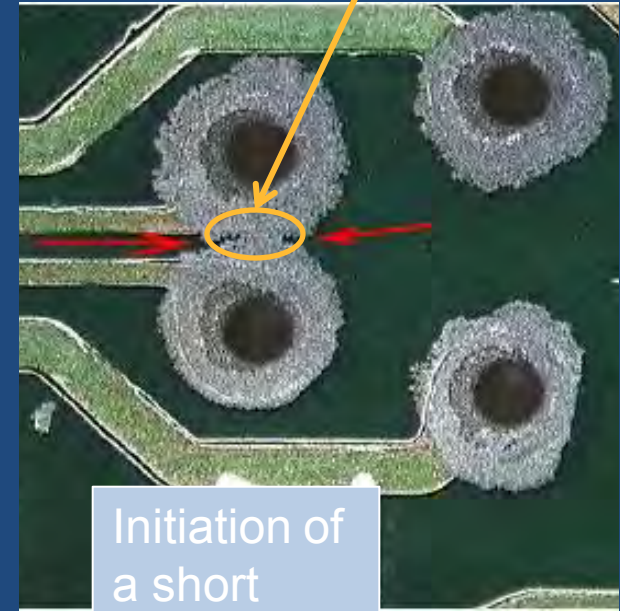
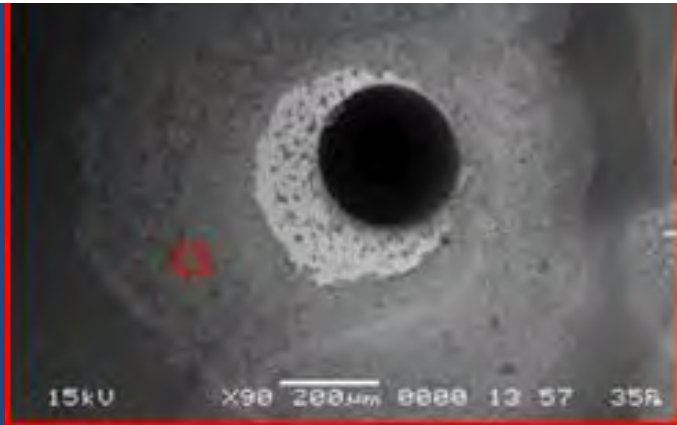
No Failures in Survey Example – Short Caused by Creep Corrosion on Immersion Silver Type Printed Circuit Boards

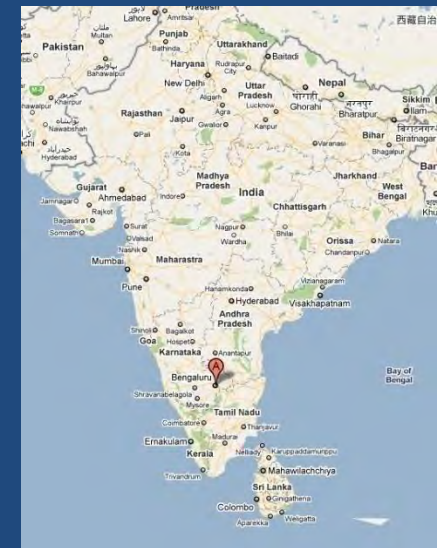
Data Center Corrosivity Limited Survey

performed by Lawrence Berkeley National Laboratory
Locations in US (19 data centers) and Bangalore India (2 data centers)

Coupons exposed for one thirty day period during Aug. – Nov. 2010

15. Bangalore India

1. Silicon Valley CA
2. Dublin CA
3. Rocklin CA
4. Research Triangle Park NC
5. Fresno CA
6. Richardson TX
7. Atlanta GA
8. Los Angeles CA
9. Chicago IL
10. Phoenix AZ
11. San Francisco CA
12. Boston MA
13. Dallas TX
14. Piscataway NJ

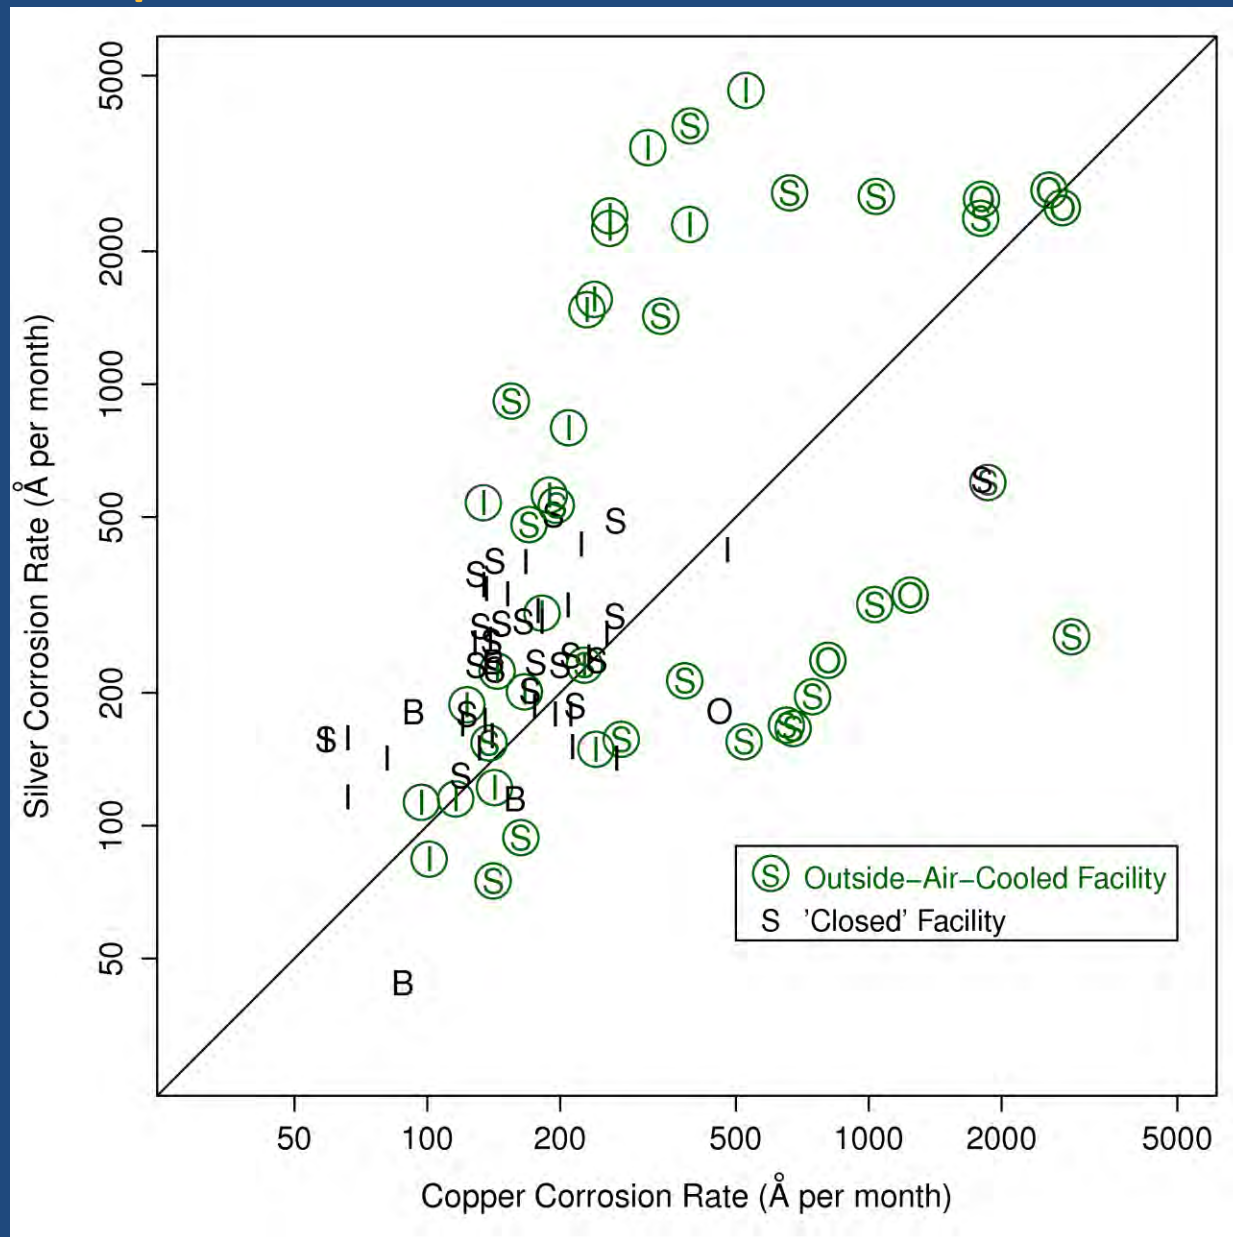
All Coupon Measurements

O = outside

S = in supply ducts

I = inside near IT equip.

B = background
(not deployed)
